**SECTION 3.3**  
**HISTORICAL RESOURCES**

## 3.3 HISTORICAL RESOURCES

This section examines the potential impacts to historical resources that may result from development of the Proposed Project, and is based on a technical report entitled *Historic Resource Inventory and Evaluation for the San Diego State University Plaza Linda Verde Project, San Diego, California*, prepared by ASM Affiliates (July 2009). This technical report provides the results of an inventory and evaluation of historical resources within the Area of Potential Effect ("APE") for the Proposed Project. The technical report is included in its entirety in **Appendix 3.3** of this EIR.

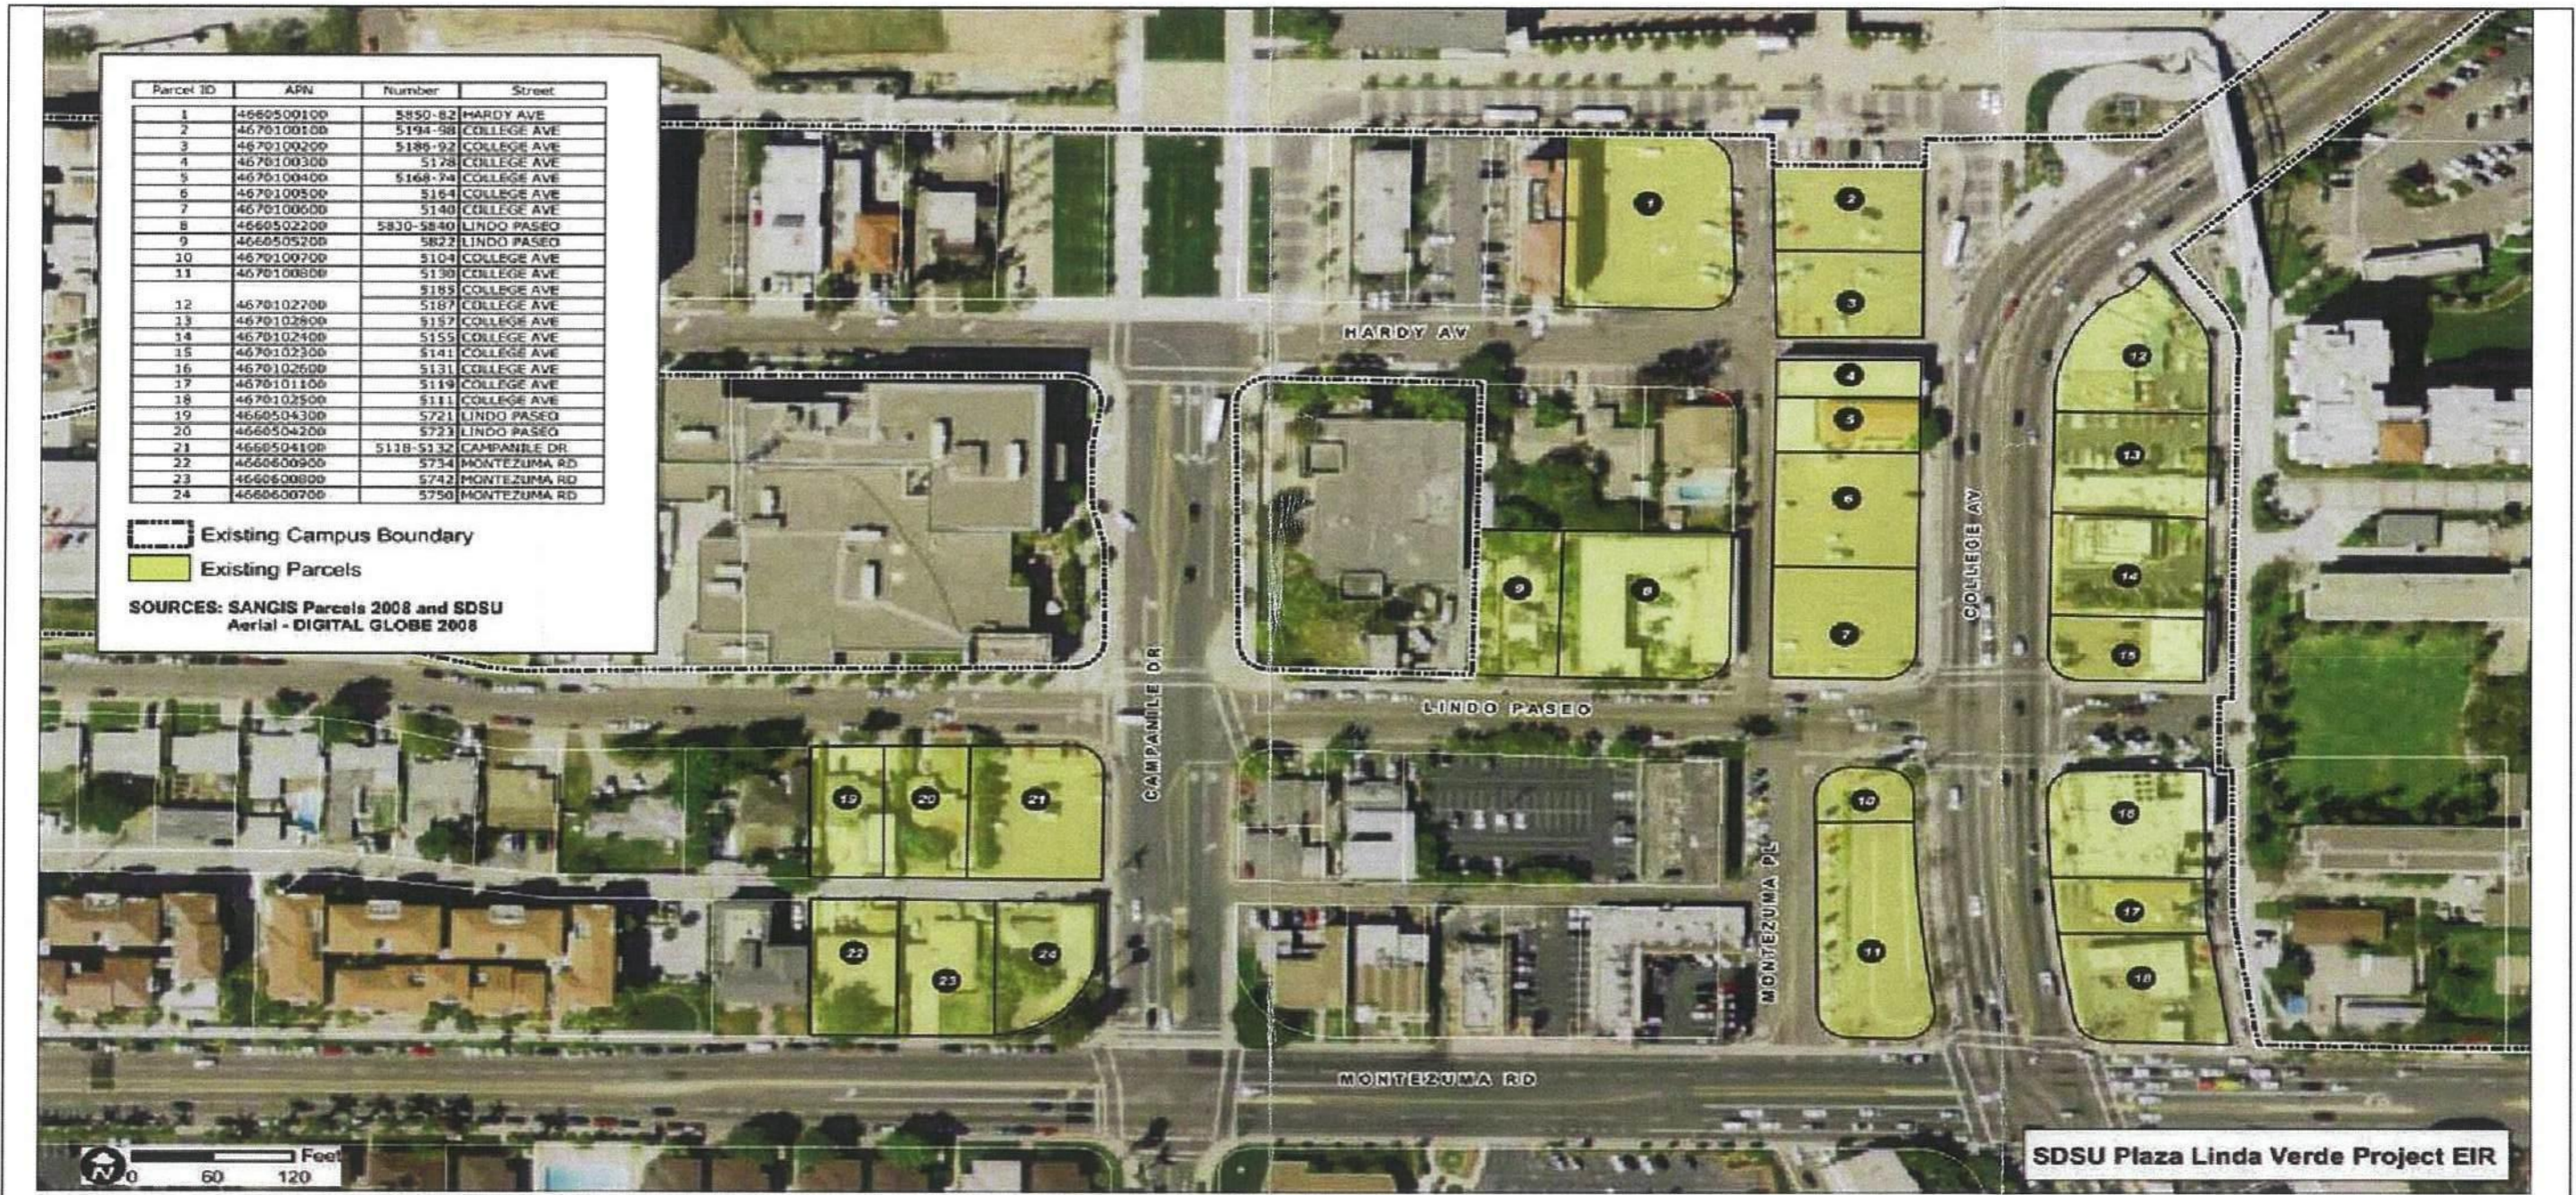
Figure 3.3-1, Aerial View of Area of Potential Effect, and Table 3.3-1, Existing Buildings Within The Project Area, depict (graphically and in a tabular format) the buildings evaluated in the historical and cultural resources inventory. As depicted on Figure 3.3-1 and Table 3.3-1, fifteen existing buildings would be directly affected by development of the Proposed Project. The attributes of each building are summarized below; further information regarding each of the buildings, including photographs of each, are provided in the technical report in Appendix 3.3.
