## Report of Preliminary Geotechnical Investigation – Evolve Student Housing

**REPORT OF PRELIMINARY GEOTECHNICAL EVALUATION  
EVOLVE STUDENT HOUSING  
SAN DIEGO STATE UNIVERSITY  
SAN DIEGO, CALIFORNIA**

Project No. SD814  
June 7, 2024

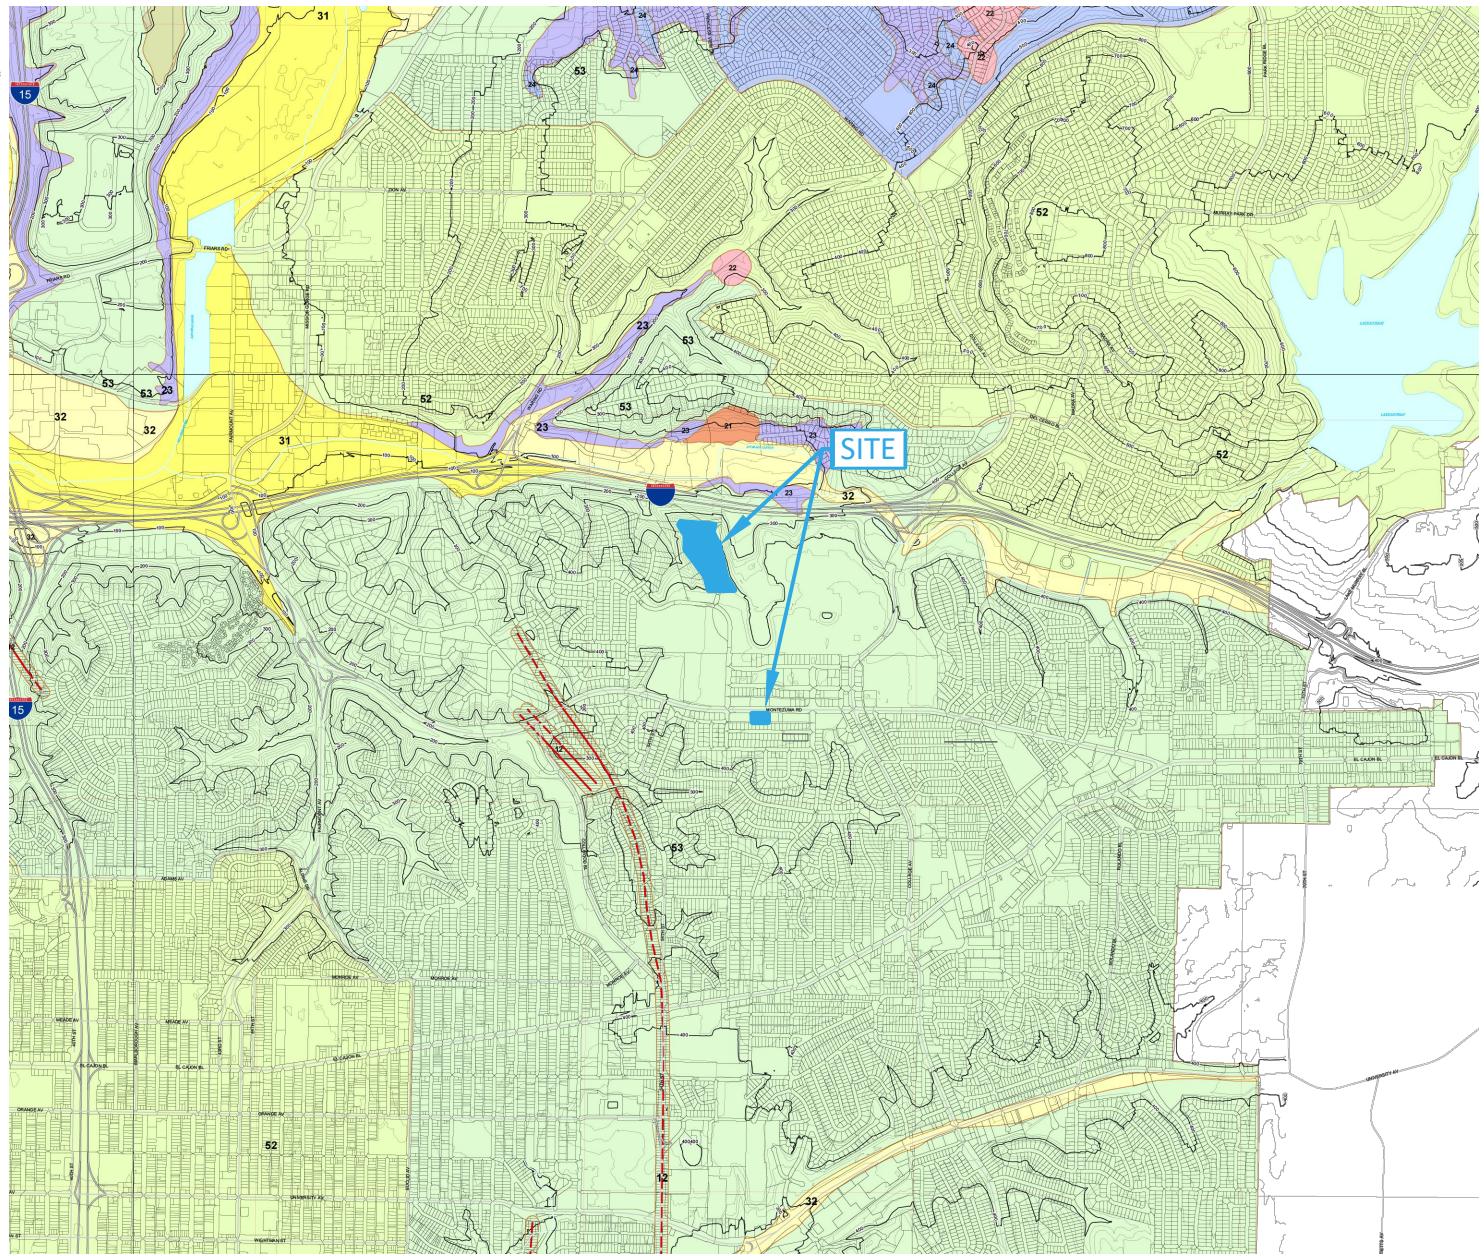
SAN DIEGO  
SEISMIC SAFETY STUDY MAP

SDSU EVOLVE STUDENT HOUSING

The Sites are not located within an area previously known for significant geologic hazards. As shown in Figure 3 the Sites are located within the City of San Diego Seismic Safety Study (City of San Diego, 2008), Geologic Hazard Category 53, which is characterized as “level or sloping terrain, unfavorable geologic structure, low to moderate risk.” The primary geologic hazard at the Sites should be the potential for strong ground motion from an earthquake. The potential geologic hazards are described below.

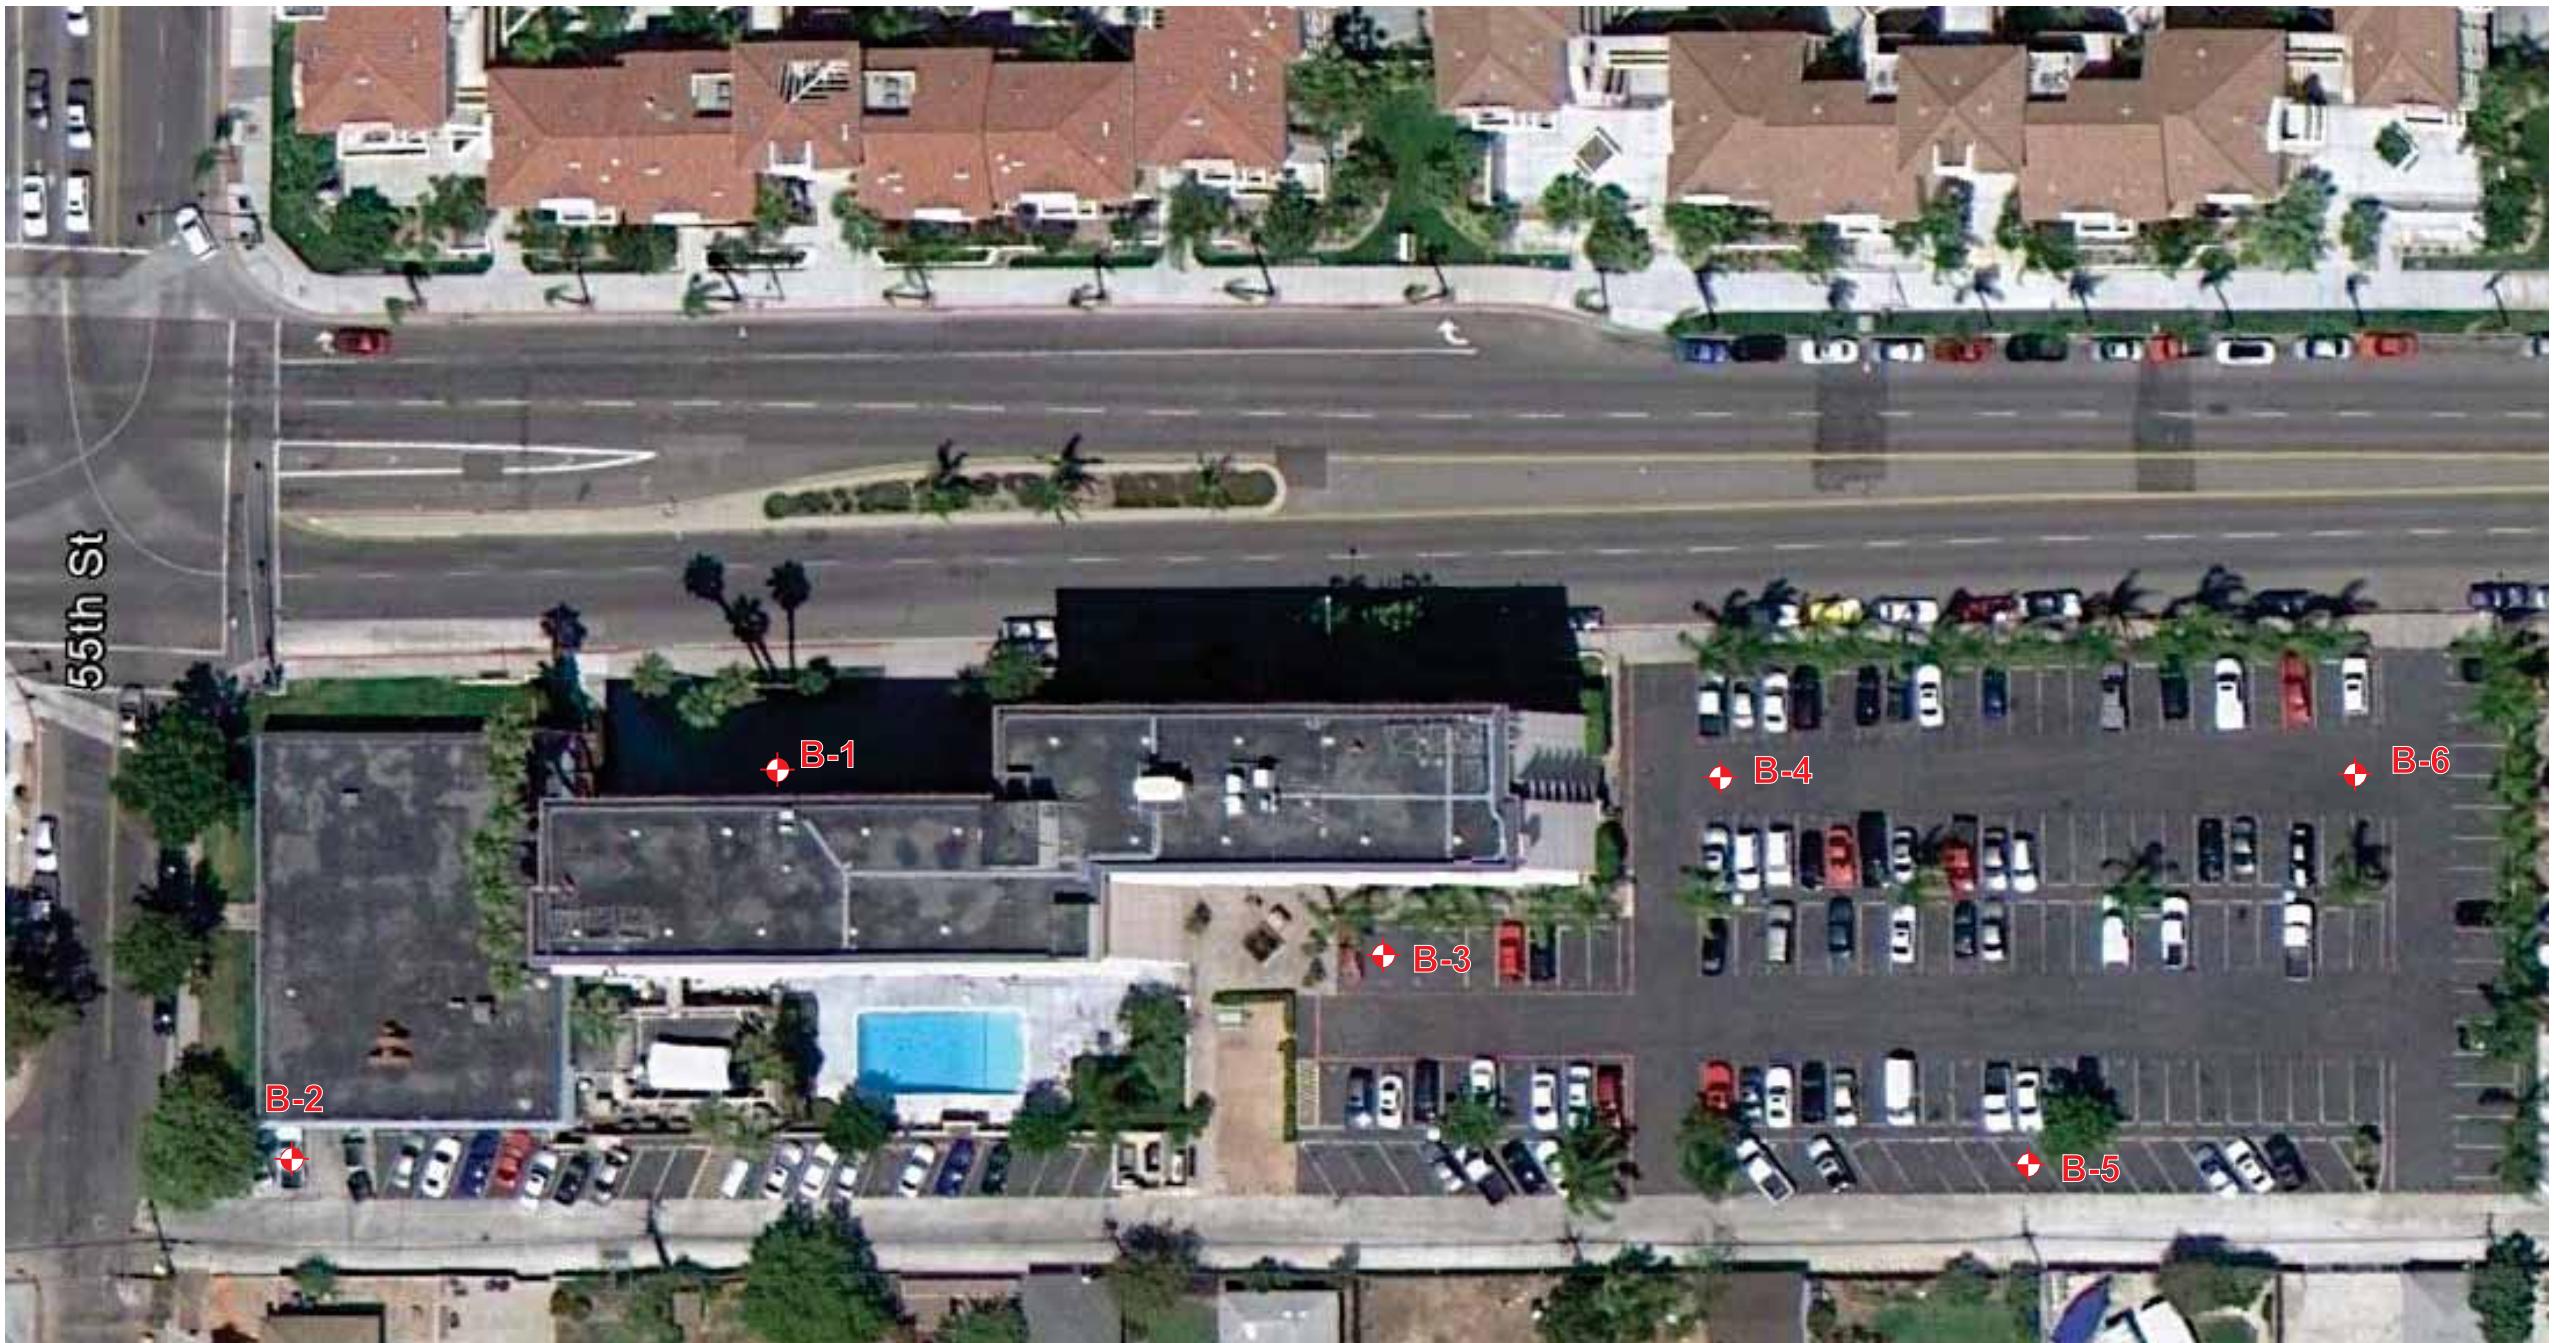
***SITE 1***

◆ B-6 Approximate location of exploratory borings

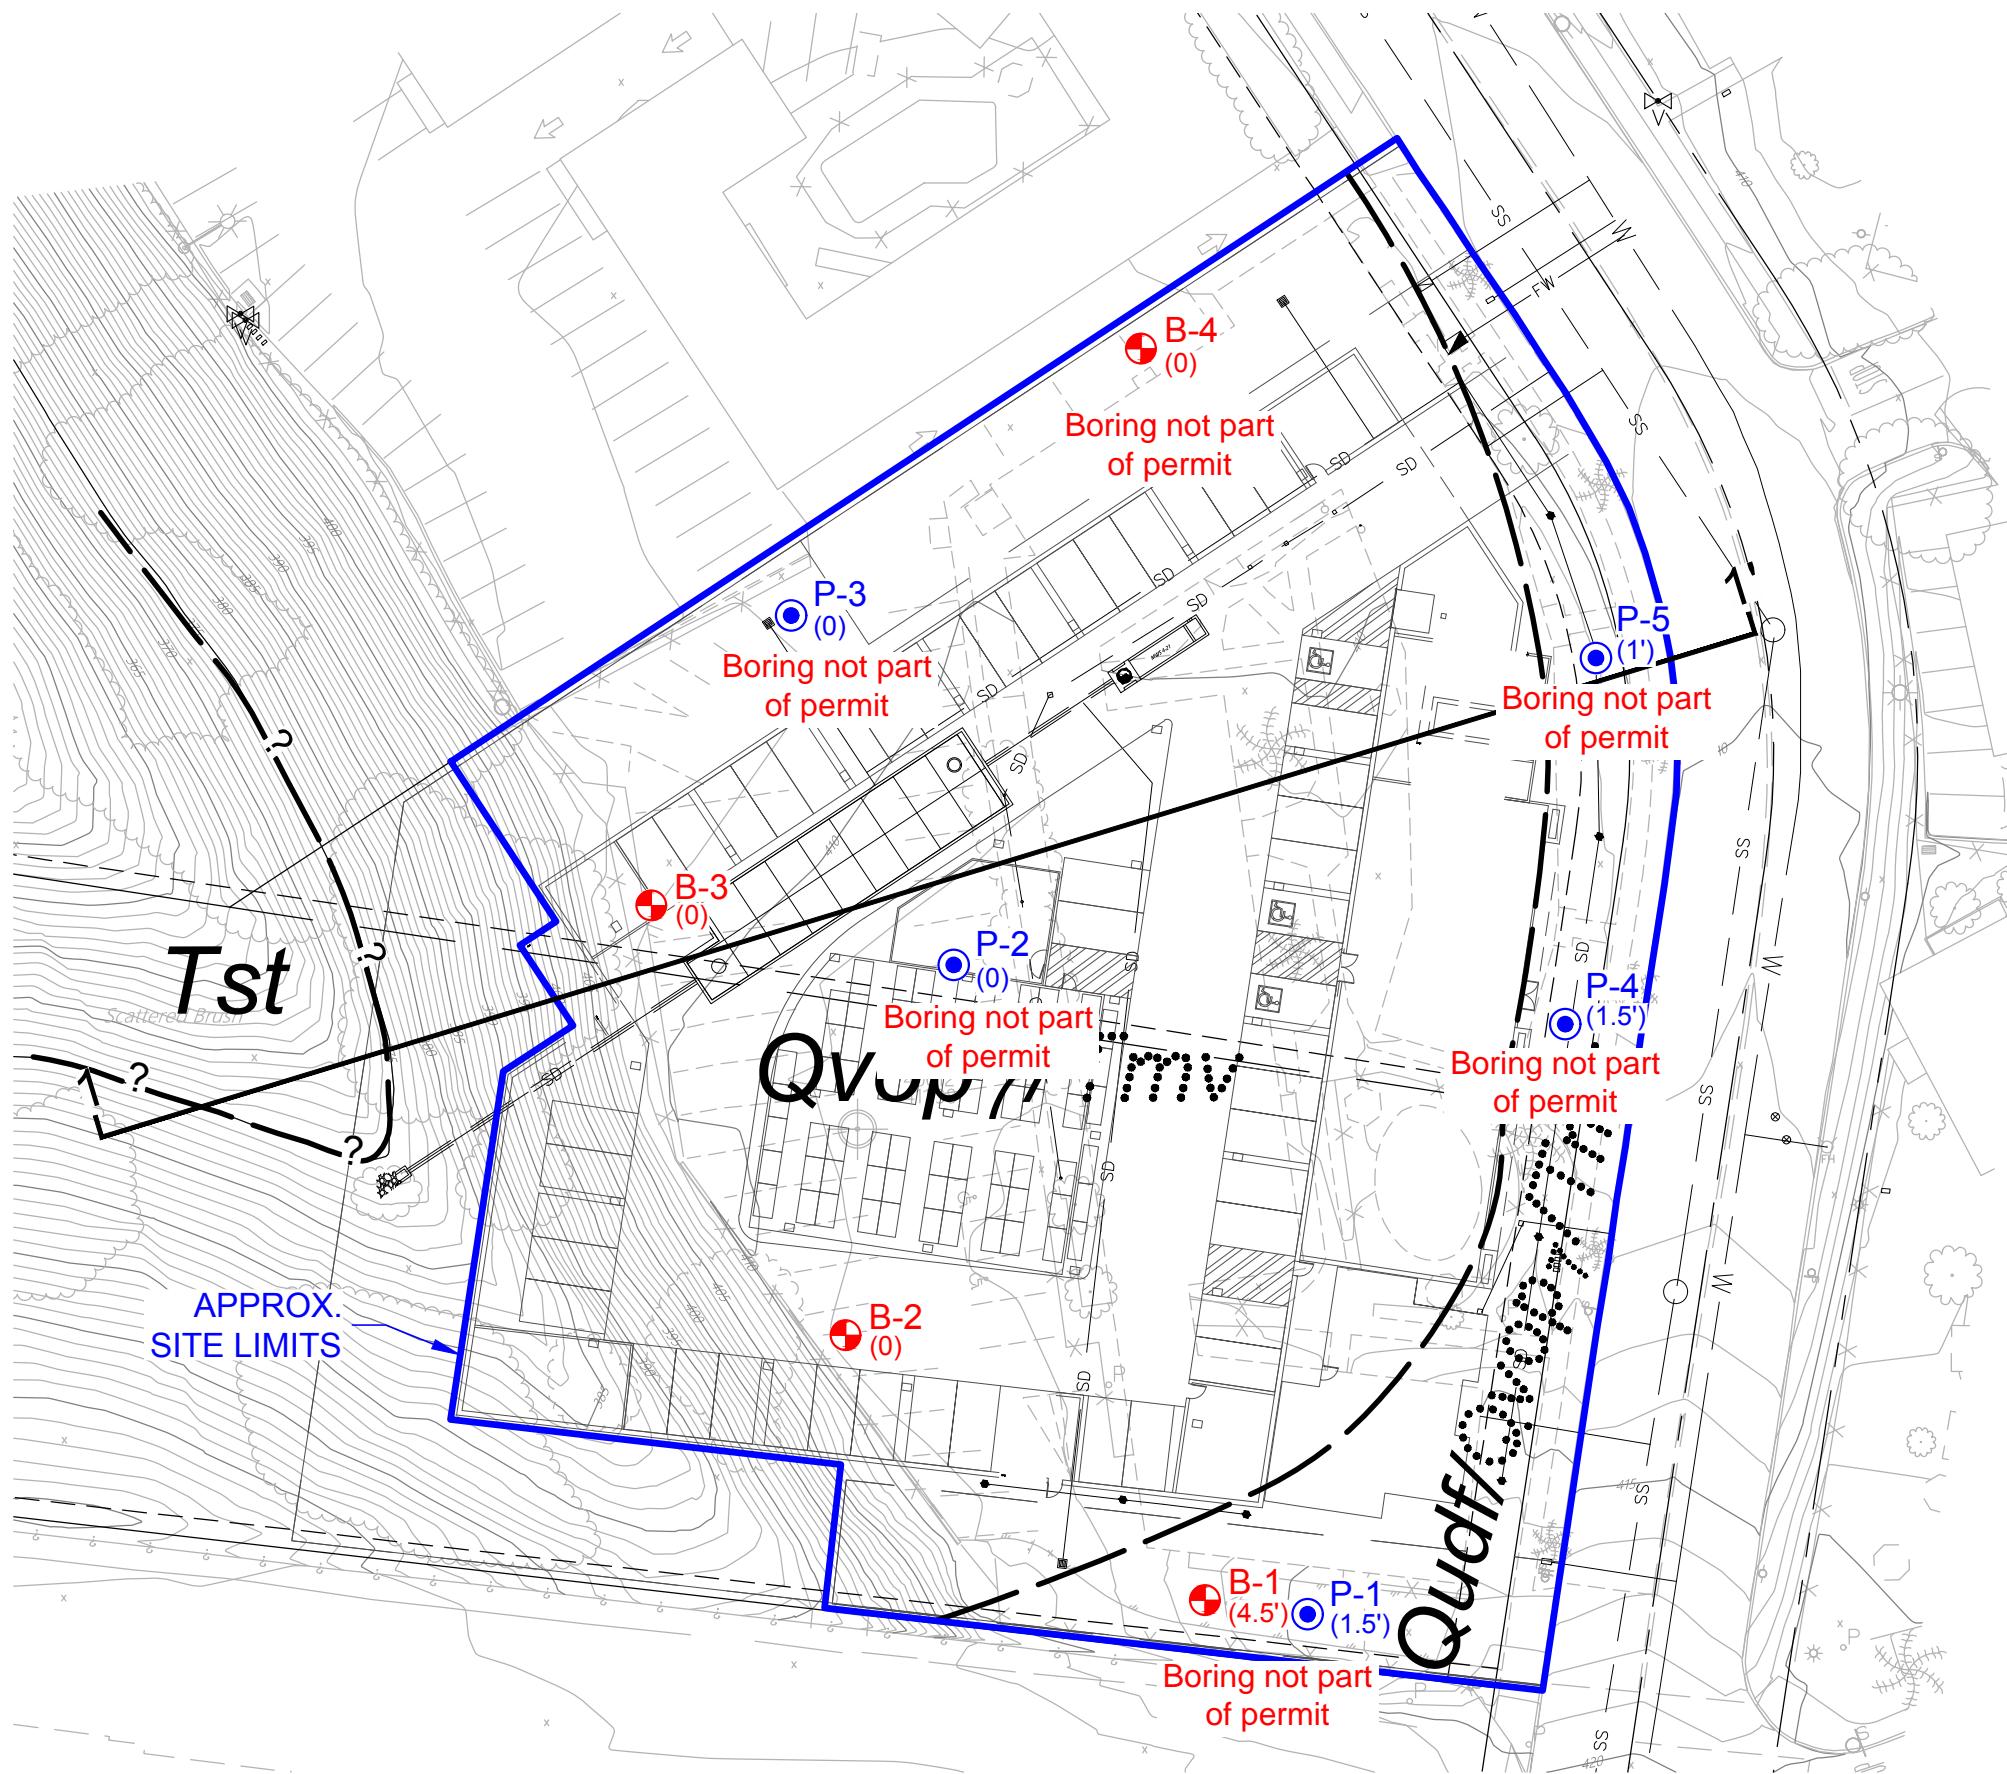
GEOCON LEGEND

- Qudf** ..... UNDOCUMENTED FILL
- Qvop** ..... VERY OLD PARALIC DEPOSITS (Dotted Where Buried)
- Tmv** ..... MISSION VALLEY FORMATION (Dotted Where Buried)
- Tst** ..... STADIUM CONGLOMERATE
- ~? ..... APPROX. LOCATION OF GEOLOGIC CONTACT (Queried Where Uncertain)
- B-4** ..... APPROX. LOCATION OF BORING
- P-5** ..... APPROX. LOCATION OF AARDVARK PERMEAMETER TEST
- (4') ..... APPROX. DEPTH TO FORMATION (Feet)
- 1' ..... APPROX. LOCATION OF GEOLOGIC CROSS SECTION
